# Corrosion Repairs Using The Radial Bristle Disc

By Thomas Doughty

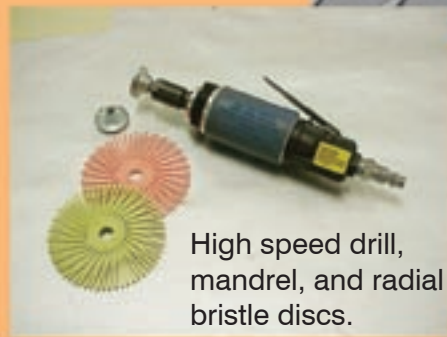
High speed drill, mandrel, and radial bristle discs.

The bristle disc requires an air source of 90 to 110 pounds per square inch, a high-speed pneumatic die grinder rated from 22,000 to 25,000 rpm (not the 3,200 rpm with most available grinders), and a mandrel assembly. You have to operate the grinder at its maximum rated speed, but you only need to apply a small amount of pressure to strip a surface. If you apply too much pressure, the bristles will fold, and the tool won’t work. You’ll avoid the “valleys” that form with flap brushes and abrasive wheels.

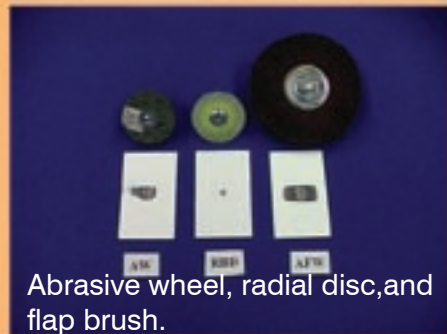
Abrasive wheel, radial disc, and flap brush.

- Reduces surface temperature. The bristle disc produces a surface temperature of about 100 degrees Fahrenheit, while the abrasive wheels yield temperatures around 200 degrees F.
- Smaller treatment area. The bristle discs are more precise and do not remove excess paint.
- Easier to use. The bristle disc requires 1.5 pounds of pressure to be applied (via the grinder) in order to remove corrosion. Abrasive wheels require 12 pounds of pressure to accomplish the same task.
